Confidential Inspection Report

Property Address:
123 Main St
Richmond, VA 23236

Inspector Name
State License: 3380001234 NRS Exp 1-31-2024
Burgess Inspections
530C Southlake Blvd
N. Chesterfield, VA 23236
(804) 794-1423

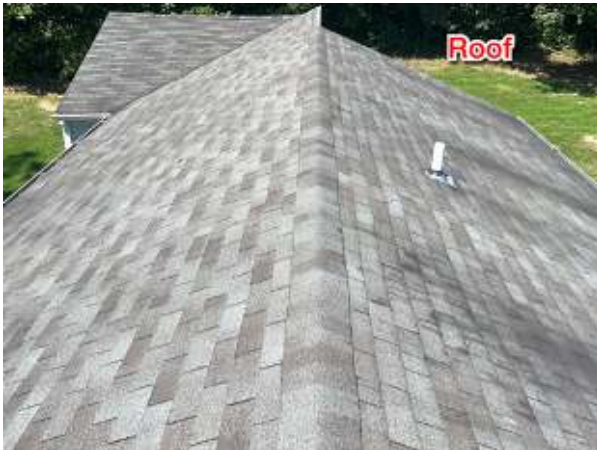
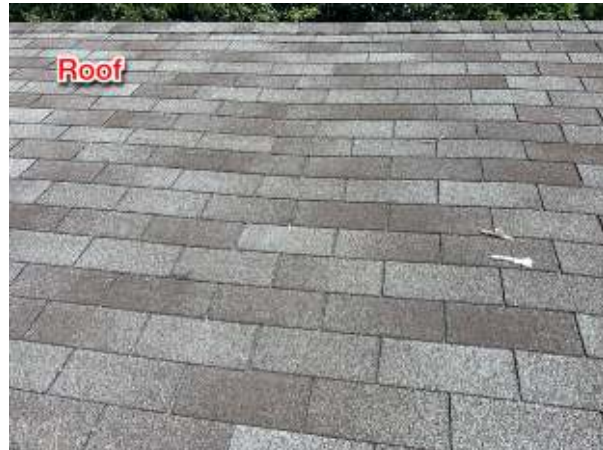
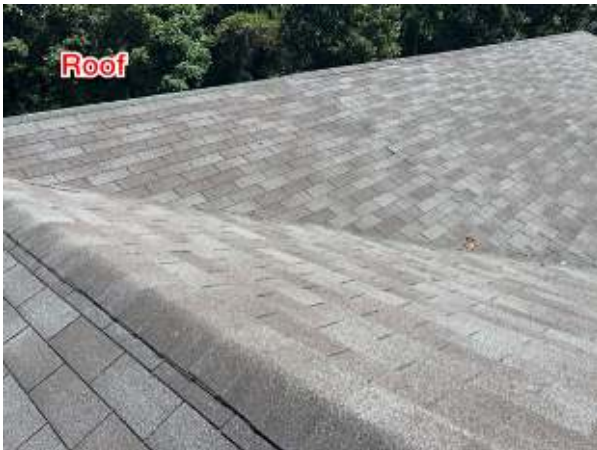
8: Cracked/damaged shingles at the right gable end of the roof.- \$200-300

s-8: Cracked/damaged shingles at the right gable end of the roof.- \$200-300

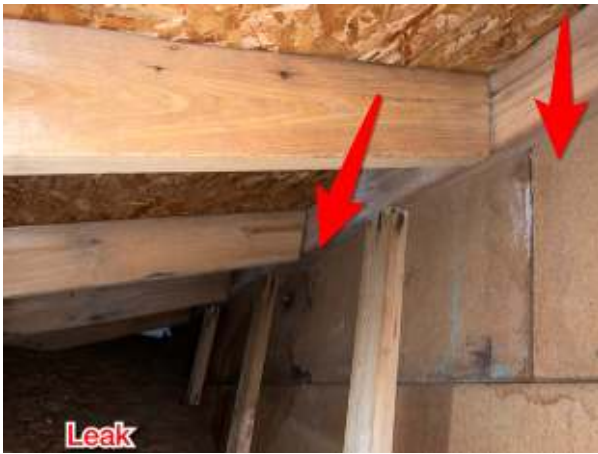
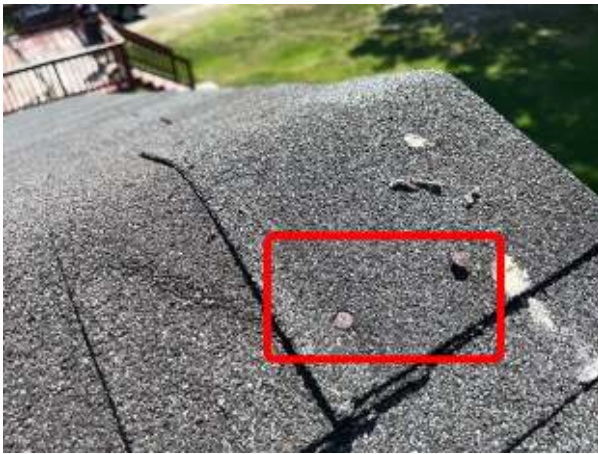
10: Exposed nail pops at several ridge caps.- \$100-300

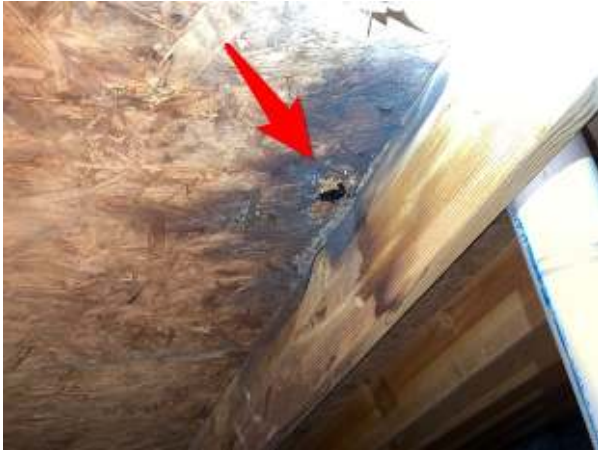
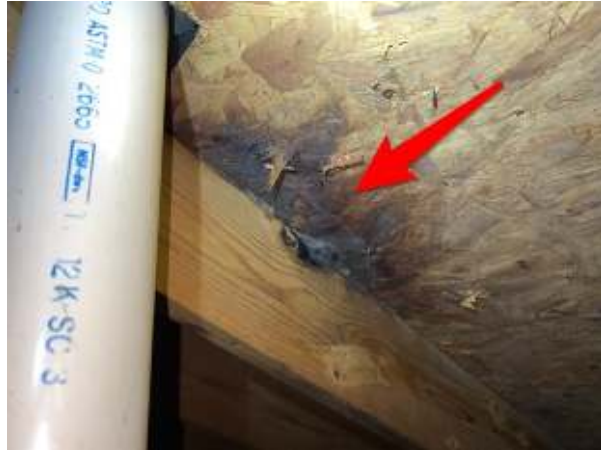
11: The flashing around the rear plumbing stack is loose and allowing water intrusion into the attic.-
\$200-300

s-11: The flashing around the rear plumbing stack is loose and allowing water intrusion into the attic.- \$200-300

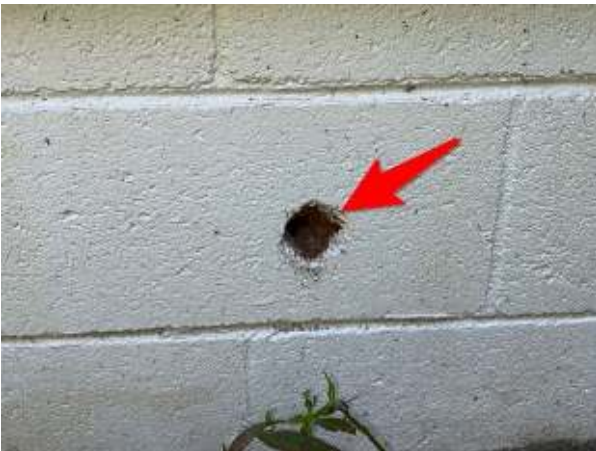
16: An open hole noted in the block wall at the rear of the home that needs to be sealed to avoid animal intrusion.- \$100

s-16: An open hole noted in the block wall at the rear of the home that needs to be sealed to avoid animal intrusion.- \$100

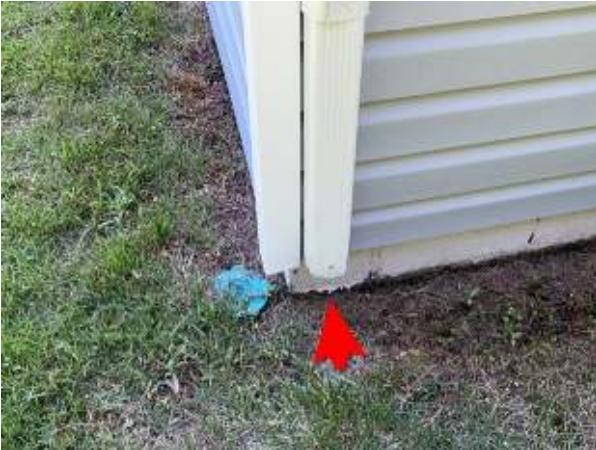
20: The downspout at the back left corner of the house need an elbow extension installed to divert the water away from the foundation.- \$100

s-20: The downspout at the back left corner of the house need an elbow extension installed to divert the water away from the foundation.- \$100

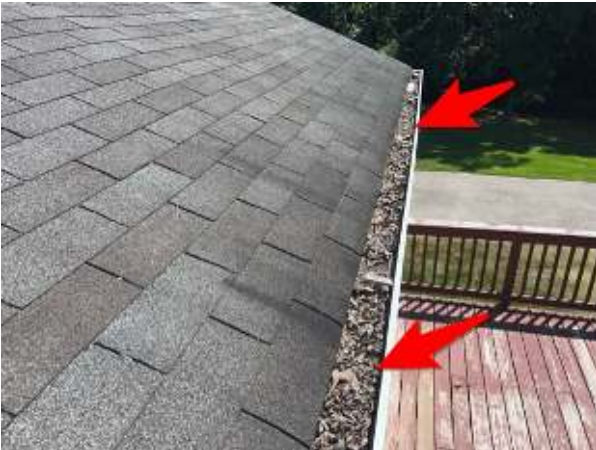
21: The gutters were full of debris and need to be cleaned.- \$100

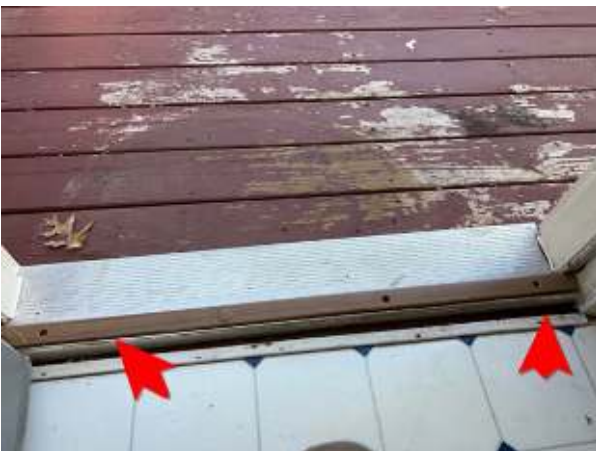
22: The back door threshold is loose. Also, the flooring below appeared to have minor rot.- \$200-300

s-22: The back door threshold is loose. Also, the flooring below appeared to have minor rot.- \$200-300

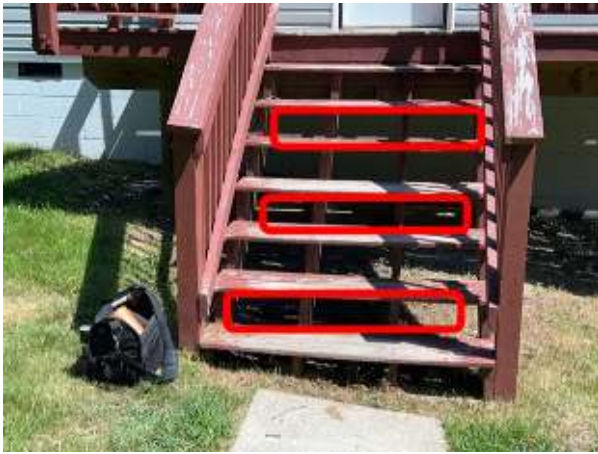
23: The front and rear stairs had an open riser, creating openings under each step. The openings exceeded the 4-inch space rule. The maximum space allowed will not let a 4-inch object pass through the area.- \$200

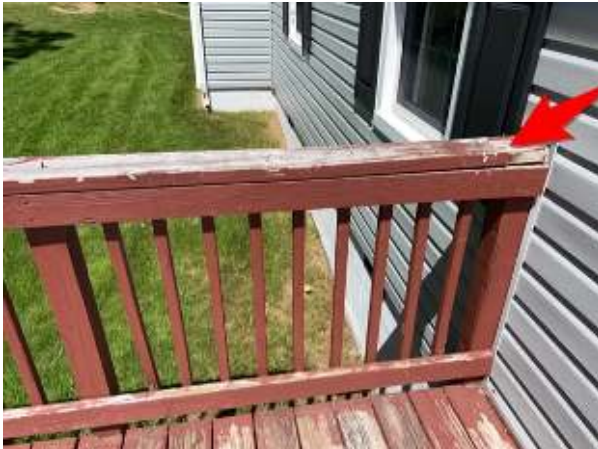
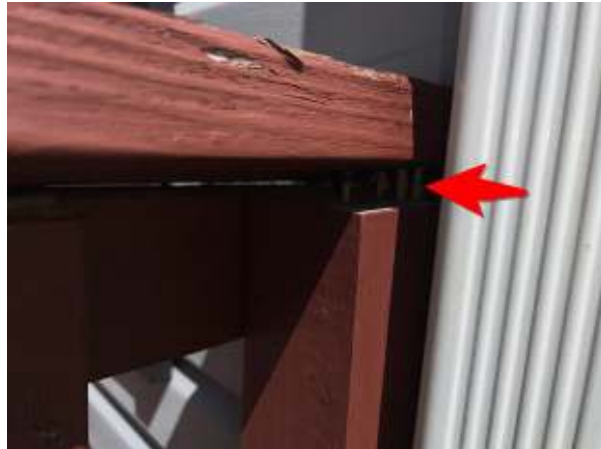
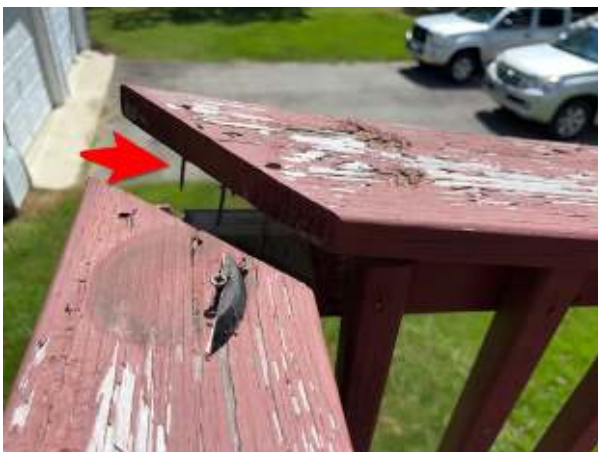
24: The back deck top rails were warped and loose.- \$100-300

s-24: The back deck top rails were warped and loose.- \$100-300

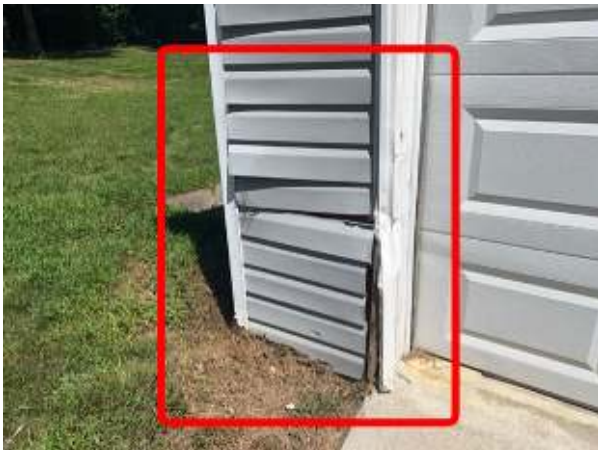
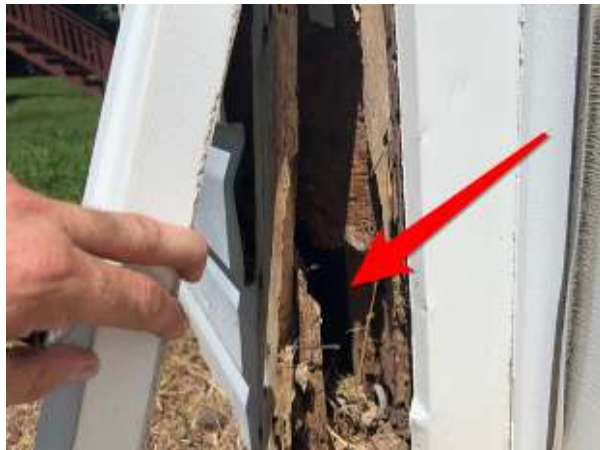
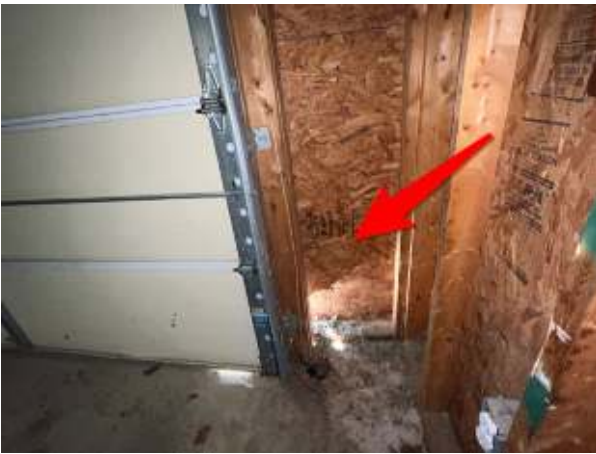
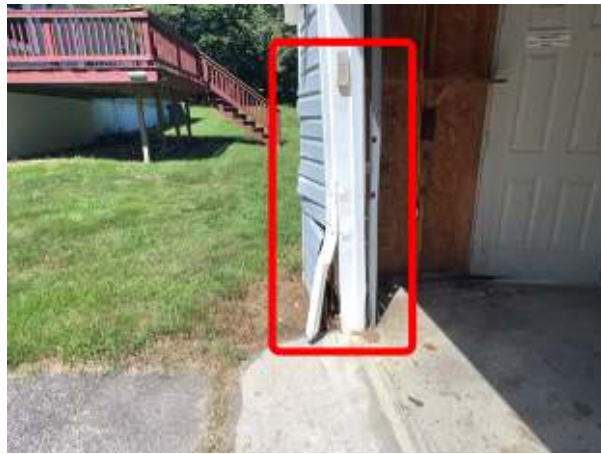
30: The front left corner of the garage has been damaged. The garage door frame has been compromised along with the front left wall.- \$800-1500

s-30: The front left corner of the garage has been damaged. The garage door frame has been compromised along with the front left wall.- \$800-1500

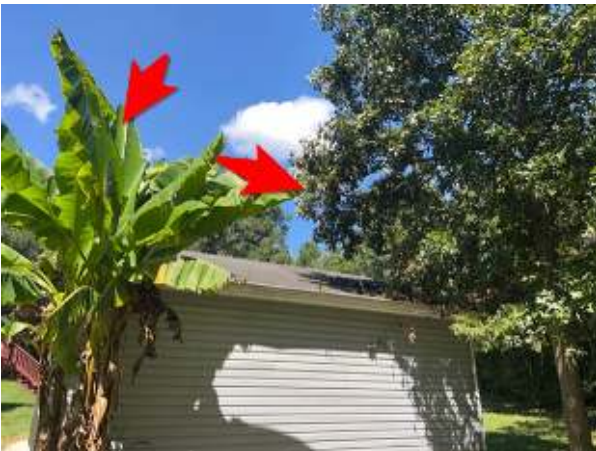
31: Recommend cutting back tree limbs hanging over and on the detached garage roof.

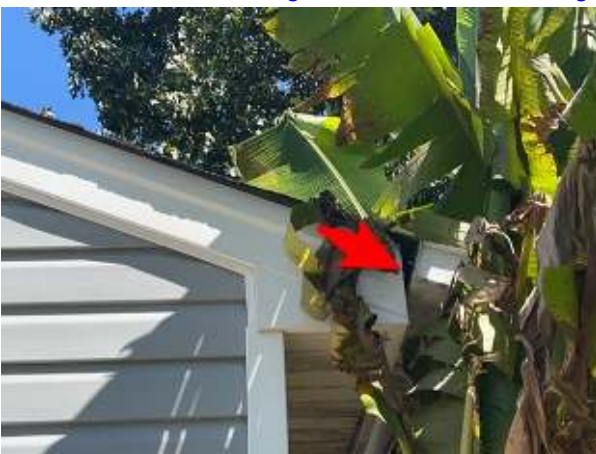
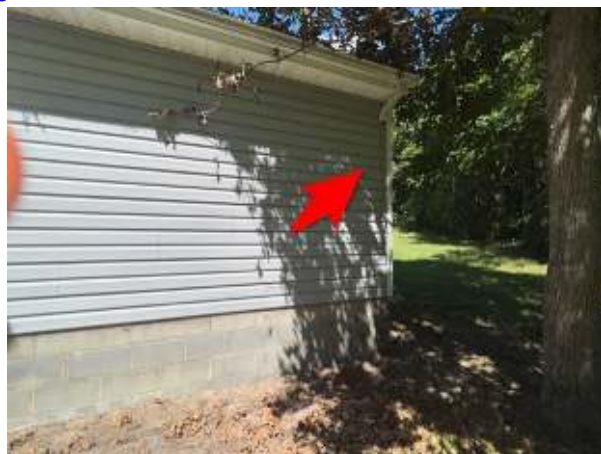
32: Missing downspout at the back right corner of the detached garage. Also, the gutter is pulling away from the fascia at the right front corner of the garage.- \$200

s-32: Missing downspout at the back right corner of the detached garage. Also, the gutter is pulling away from the fascia at the right front corner of the garage.- \$200

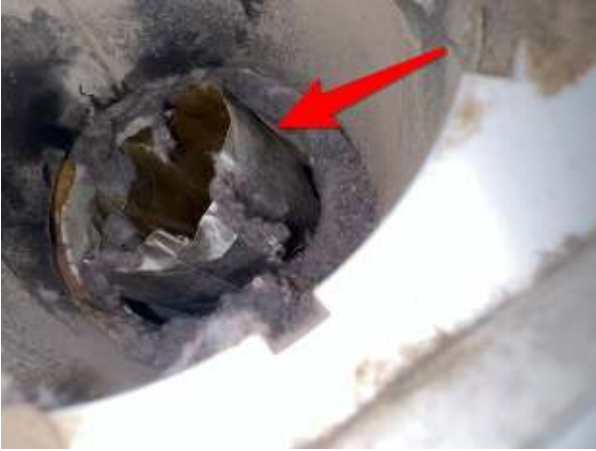
42: The dryer duct is terminated inside the wall cavity and needs to terminate to the exterior.- \$200

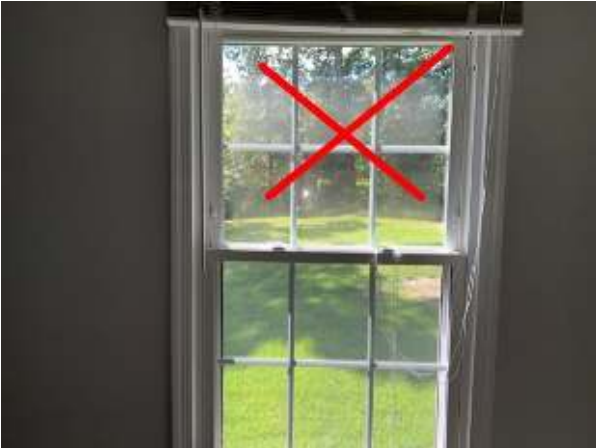
49: Failed thermal seal in the left front room window upper sash.- \$350-500

s-49: Failed thermal seal in the left front room window upper sash.- \$350-500

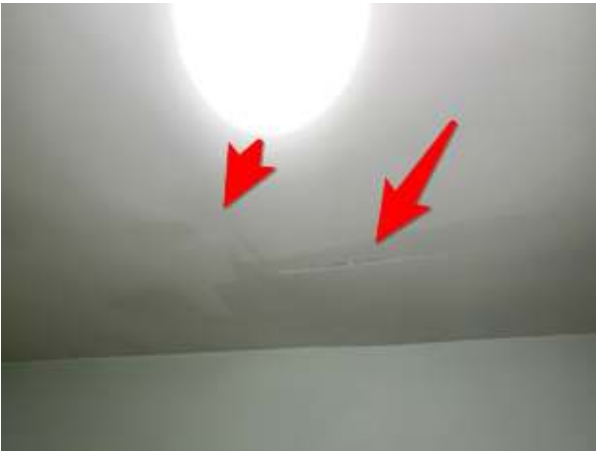
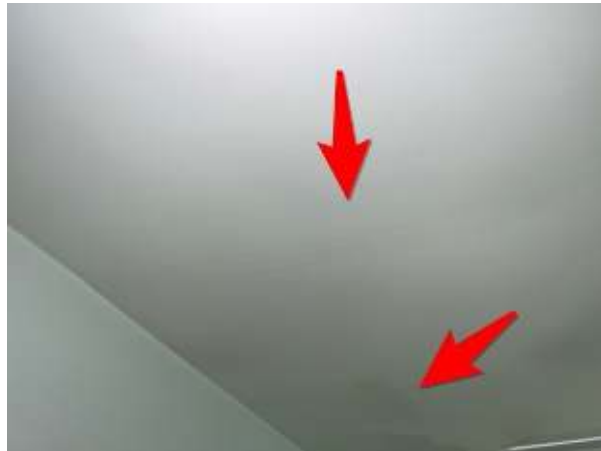
52: Water stains noted on the addition ceiling. These stains appear to be from the leaking occurring in the attic where the roof is installed improperly mentioned in the roof section.

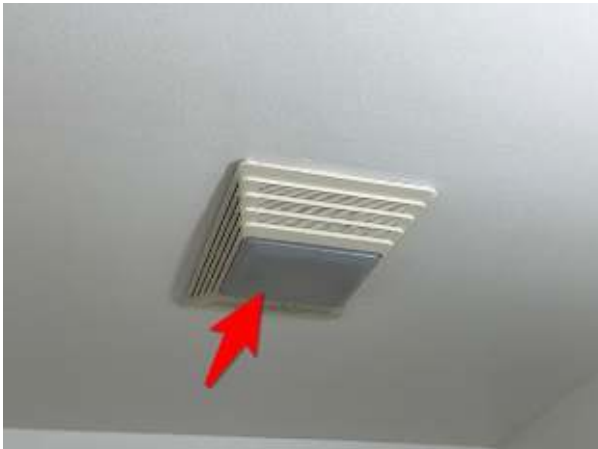
57: The exhaust fan light was not working at the time of inspection.(possible bulb out)- \$100

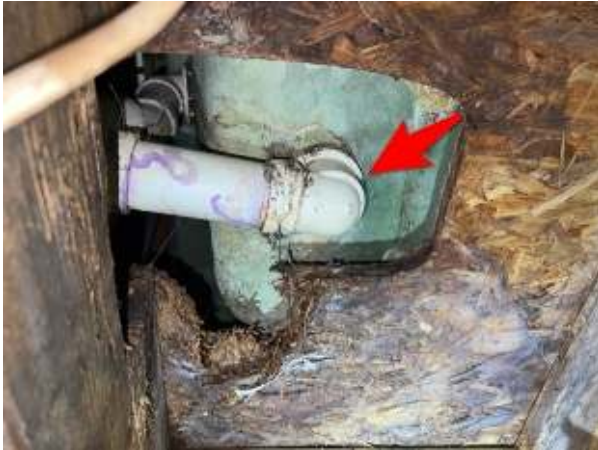
64: The hallway bathroom tub/shower drain is leaking visible in the crawl space.- \$300-500

s-64: The hallway bathroom tub/shower drain is leaking visible in the crawl space.- \$300-500

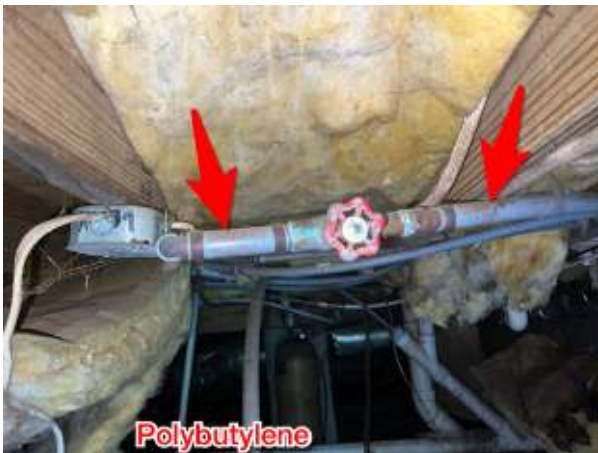
65: Most of the supply pipes for the house were plastic. It is beyond the scope of this inspection to determine what type of pipes you have. Some types have been known to prematurely fail. Polybutylene is one type that has a higher rate of failure than some others. If you have any questions or concerns about this, we recommend that you have them further evaluated by a qualified person.

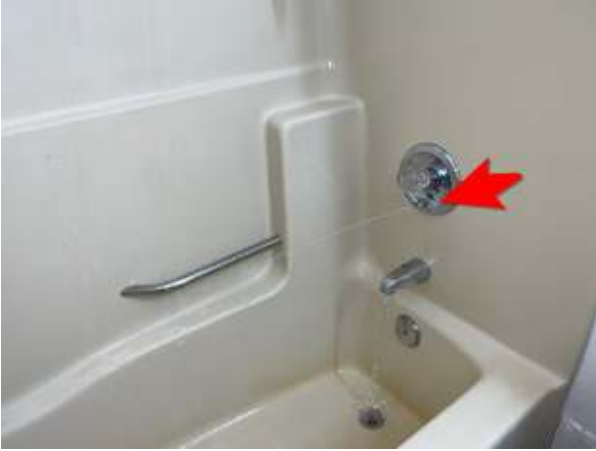
66: The hallway bathroom tub/shower diverter is leaking and needs to be replaced.- \$200

s-66: The hallway bathroom tub/shower diverter is leaking and needs to be replaced.- \$200

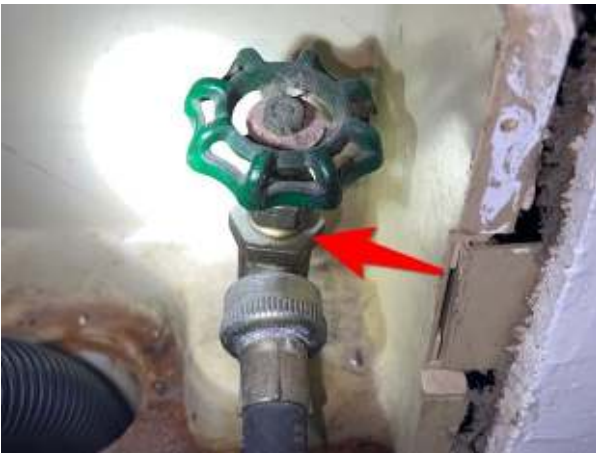
67: The cold water valve to the washing machine is leaking.- \$200

s-67: The cold water valve to the washing machine is leaking.- \$200

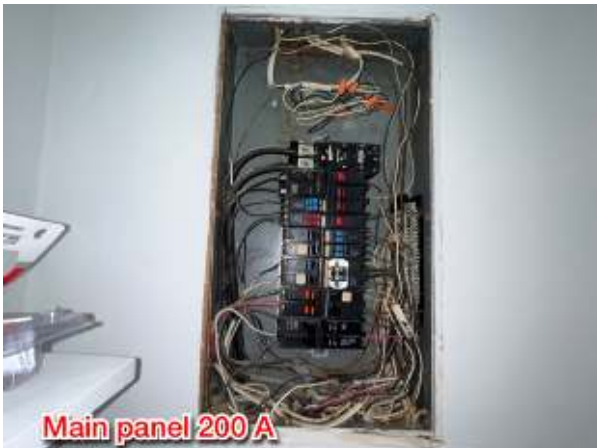
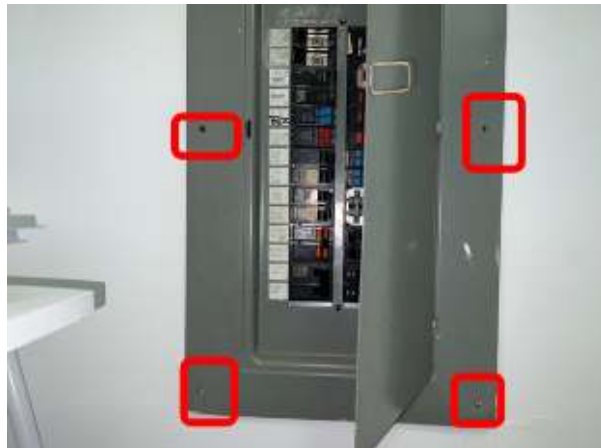
80: The main electrical panel is located in the laundry room. Also, the panel cover is missing fasteners.

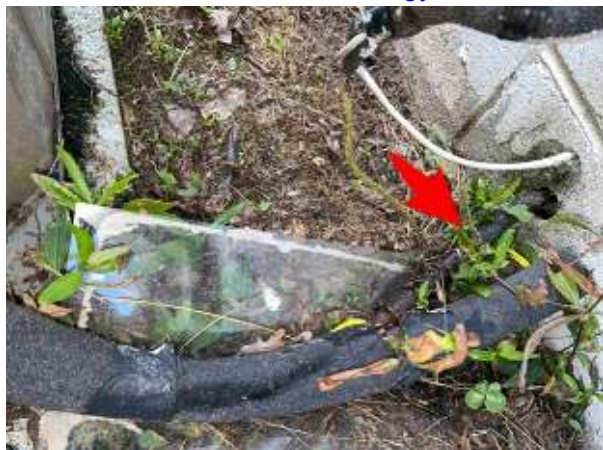
87: The foam sleeve on the suction line was missing/damaged in area(s) at the outside unit. Missing foam on suction line can cause energy loss and condensation.- \$100

s-87: The foam sleeve on the suction line was missing/damaged in area(s) at the outside unit. Missing foam on suction line can cause energy loss and condensation.- \$100

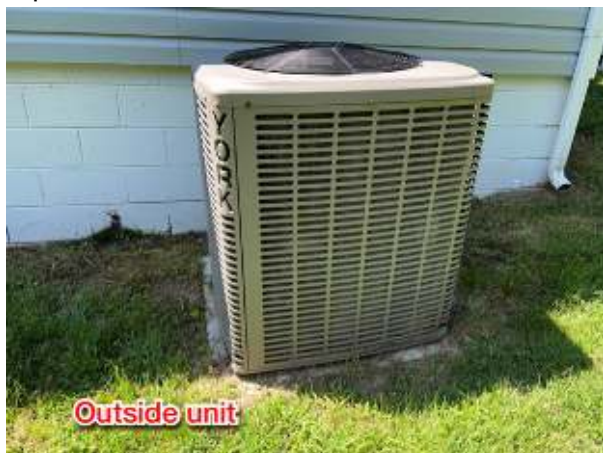
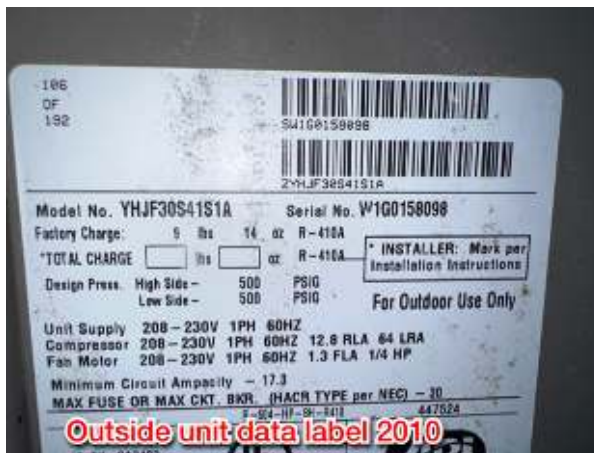
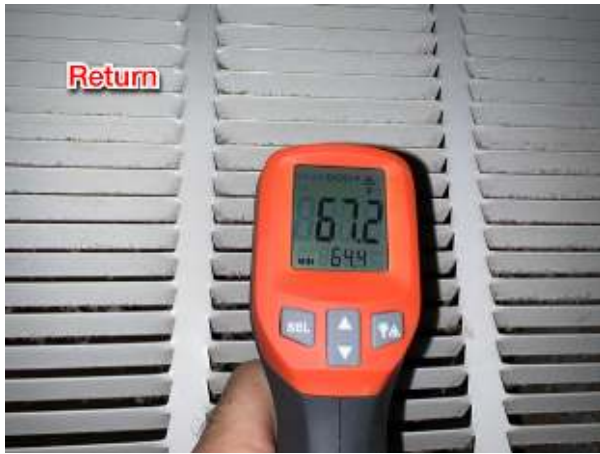
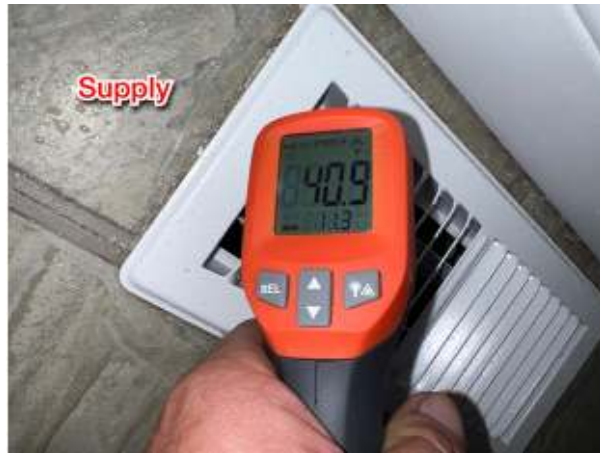
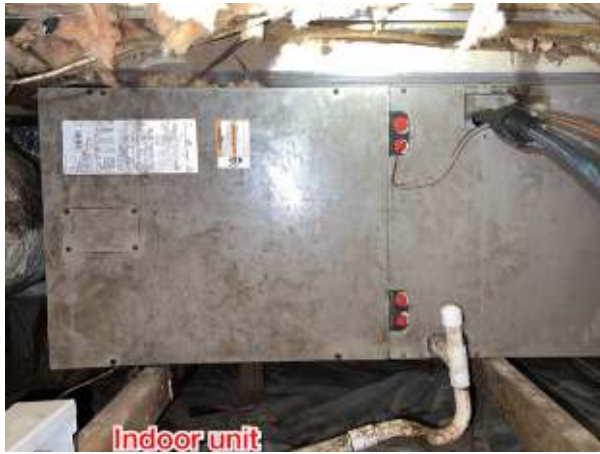
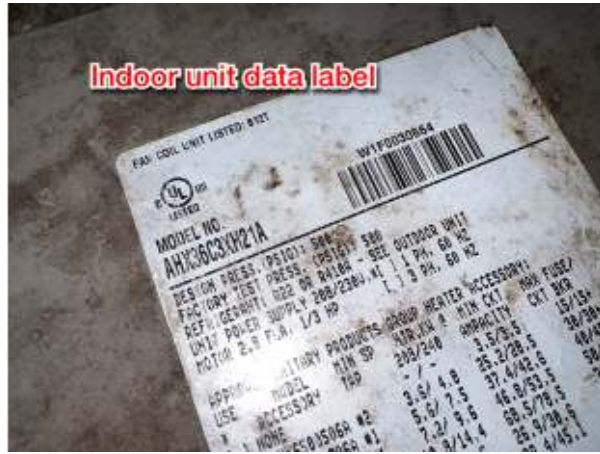
90: The heat pump was cooling adequately at the time of inspection. The filter was dirty and needs to be replaced.

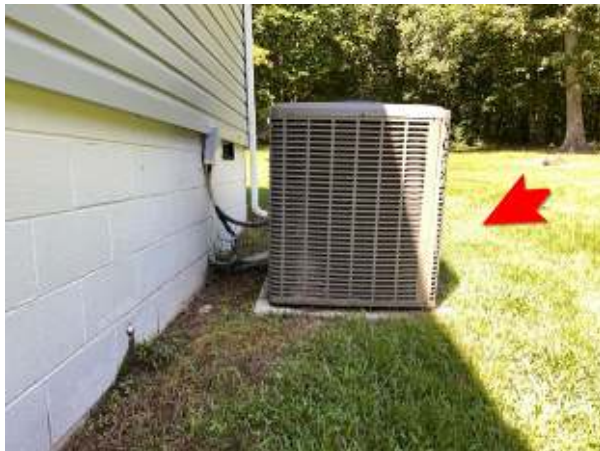
91: The outside unit was sitting in-level.- \$200

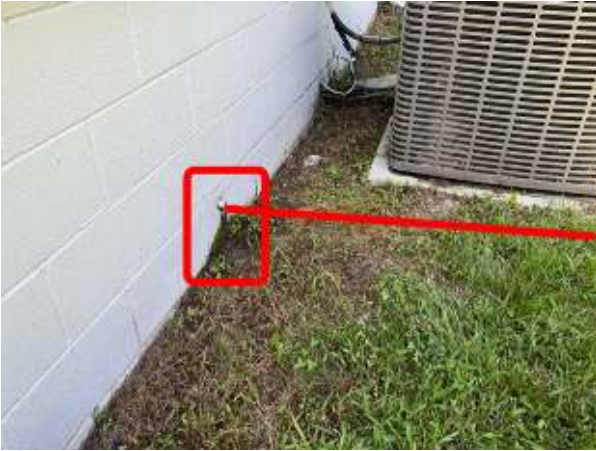
92: Recommend extending the condensation drain line further away from the foundation.

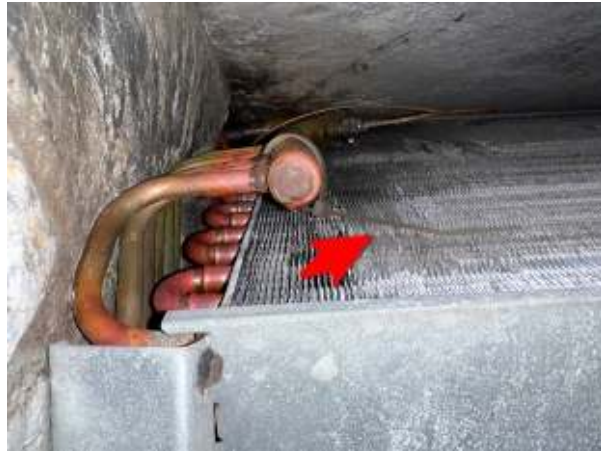
93: The indoor unit coils are dirty and need to be cleaned. Also, the cover to the air handler is losing air and needs to be sealed properly. - \$200-300

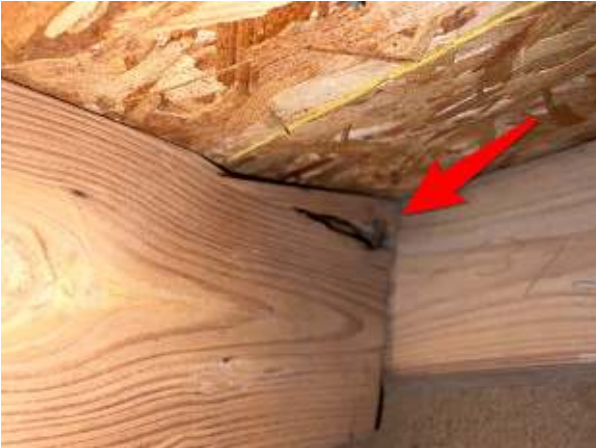
97: Minor rot to a rafter in the attic underneath the area where the roof is improperly installed over the addition.- \$200-300

s-97: Minor rot to a rafter in the attic underneath the area where the roof is improperly installed over the addition.- \$200-300

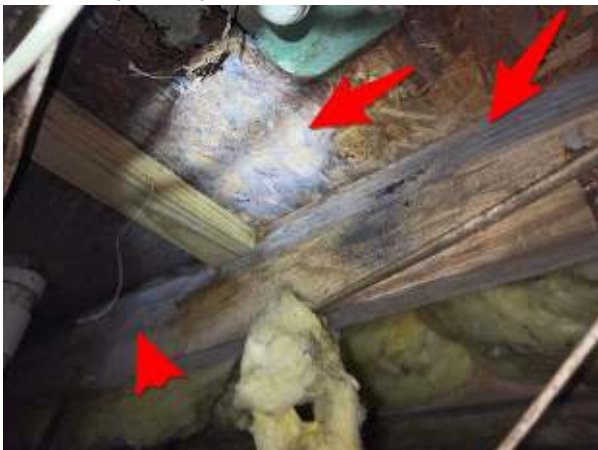
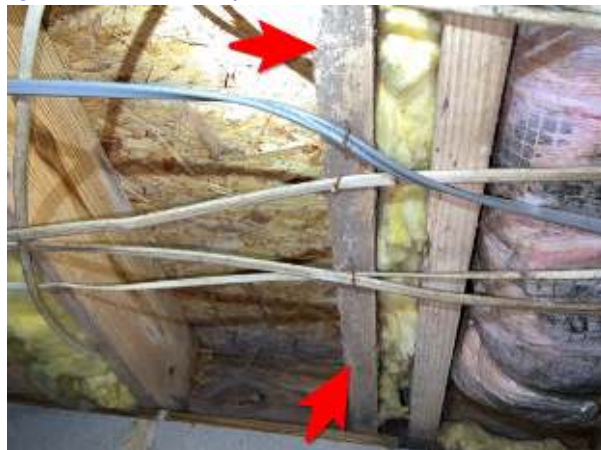
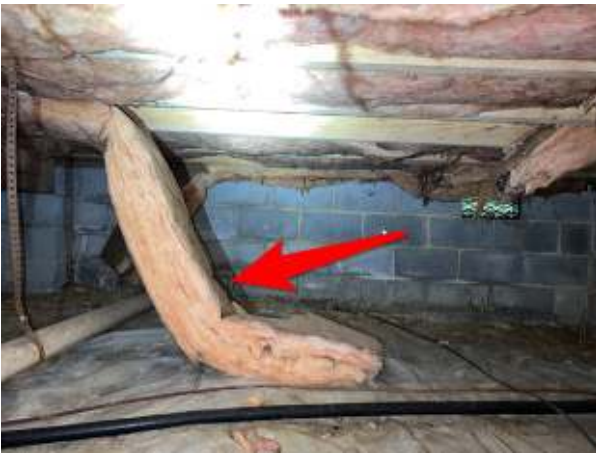
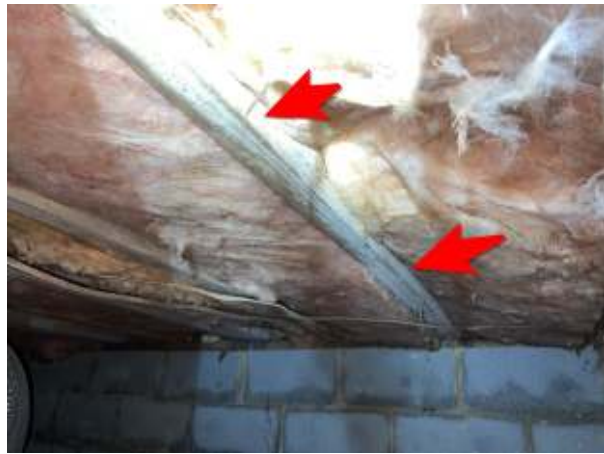
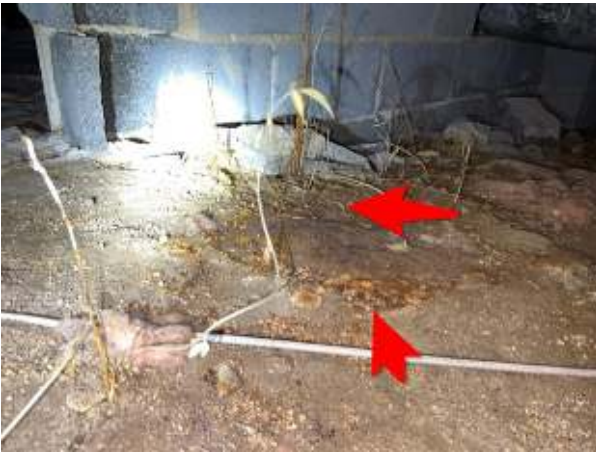
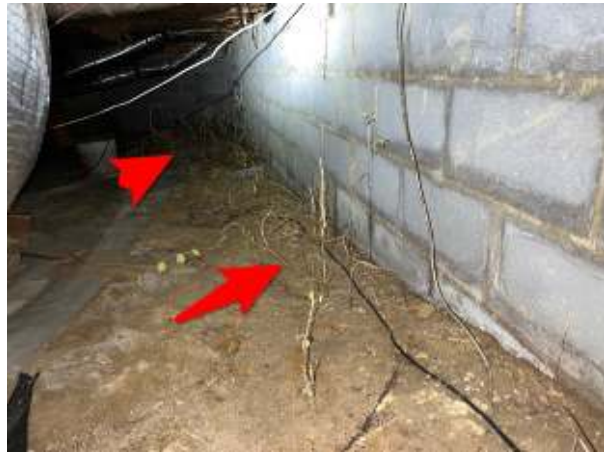
104: In the crawl space, there was a higher than normal level of fungi on the joists and ground. The insulation was feathered/hanging which is a sign of moisture. The vapor barrier was missing in many areas especially around the foundation walls. The ground was damp in these areas.- \$1000-2000

s-104: In the crawl space, there was a higher than normal level of fungi on the joists and ground. The insulation was feathered/hanging which is a sign of moisture. The vapor barrier was missing in many areas especially around the foundation walls. The ground was damp in these areas.- \$1000-2000

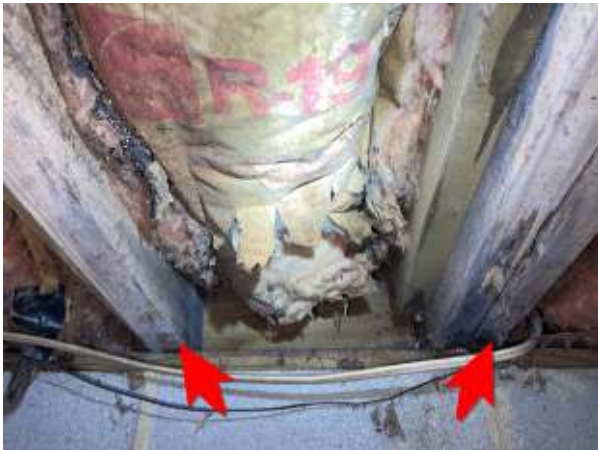
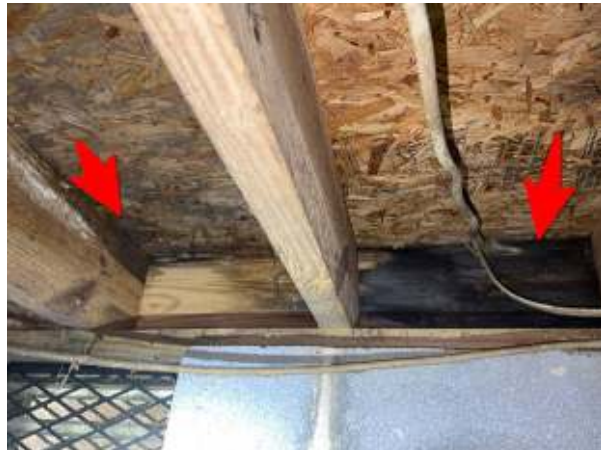
106: There were a few floor joists in the crawl space around the front porch area that have rot. Water stains noted in this area from possible water intrusion occurring around the porch area.- \$500-800

s-106: There were a few floor joists in the crawl space around the front porch area that have rot. Water stains noted in this area from possible water intrusion occurring around the porch area.- \$500-800

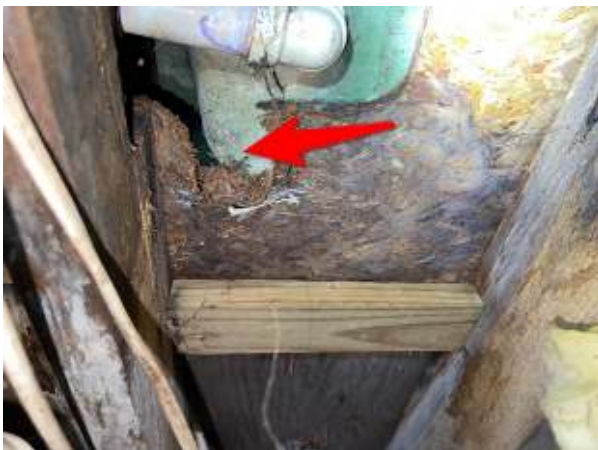
107: An area of floor sheathing is rotted due to the leak from the hallway bathroom shower drain.- \$200-300

s-107: An area of floor sheathing is rotted due to the leak from the hallway bathroom shower drain.- \$200-300
