Confidential Pool Inspection Report

LOCATED AT:
6565 Main St
Midlothian, VA 23113

INSPECTED ON:
Friday, December 8, 2023

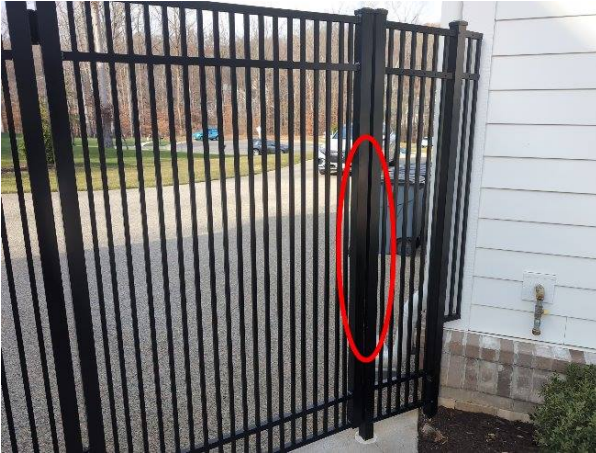
6: The front gate near the garage has the latch on the exterior. The latch is not easily reached from inside the gate. Correct as needed.

Unable to open from the inside

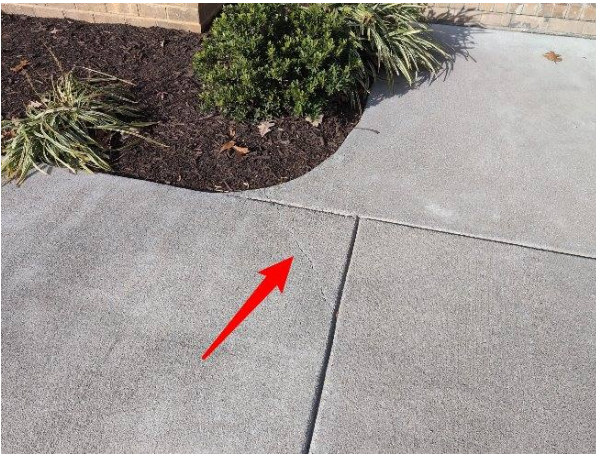
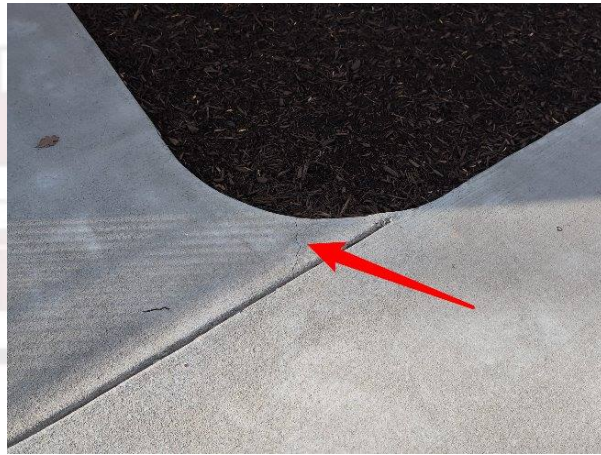
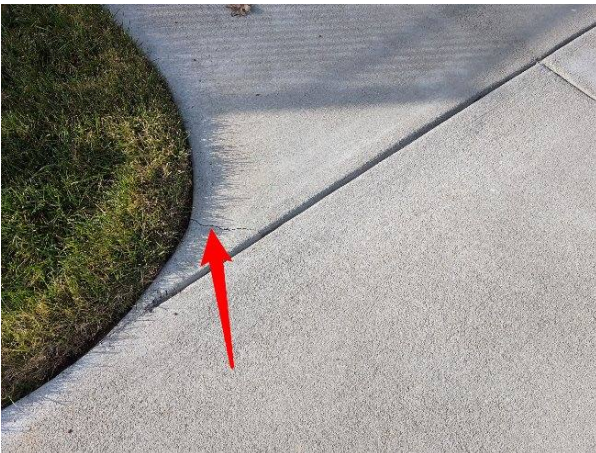
7: There was cracking observed at the pool deck. Sealing to prevent further damage during freeze/thaw cycles is recommended. Location: near the patio and near the entrance to the garage.

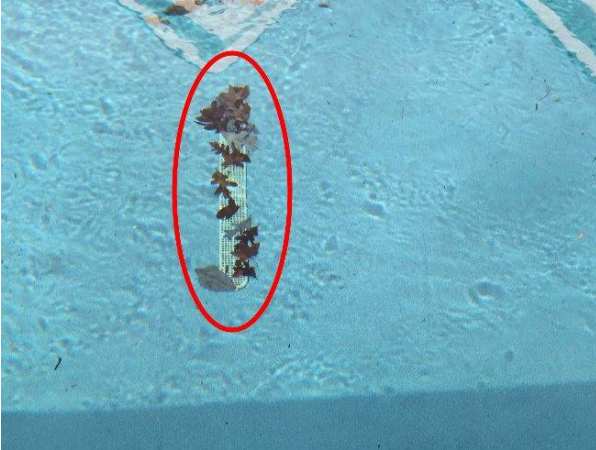
9: The skimmer box and cover were inspected.

10: It could not be determined if the cover was VGB compliant. Further verification is recommended and replaced if needed.

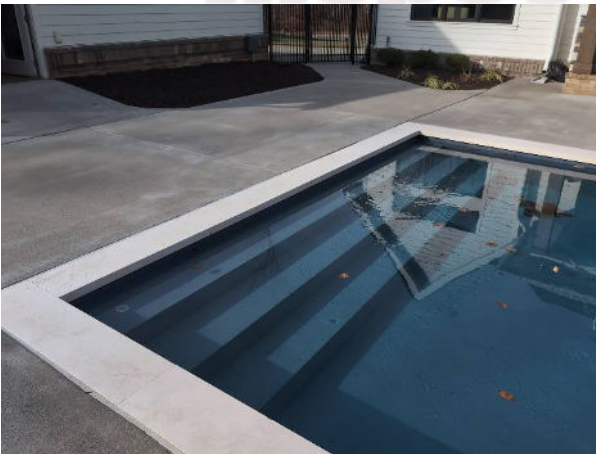
12: The handrail was missing and should be installed for safety. \$900-\$1200 +/-

Missing handrail

s-12: The handrail was missing and should be installed for safety. \$900-\$1200 +/-

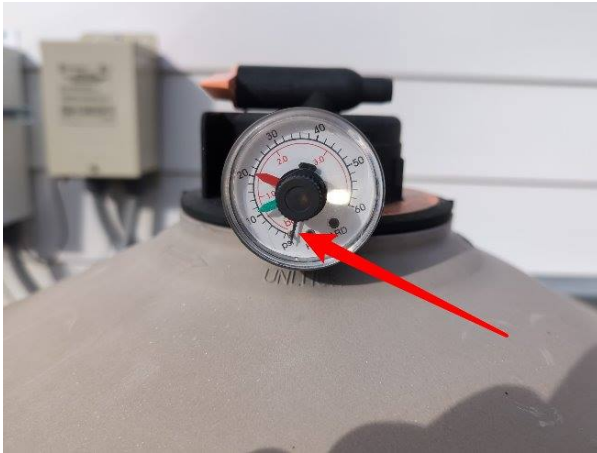
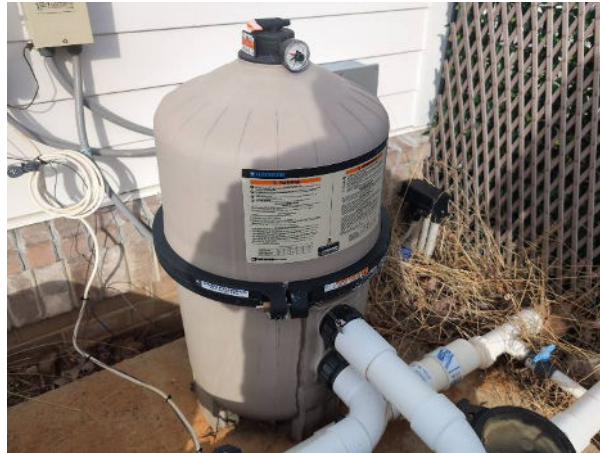
16: The pressure gauge was reading beyond 60 psi. This suggests that the filter is dirty or the gauge is not working. Recommend a licensed pool contractor evaluate and correct as needed. ~\$100-\$200 +/-

Arrow points to the reading on the gauge.

s-16: The pressure gauge was reading beyond 60 psi. This suggests that the filter is dirty or the gauge is not working. Recommend a licensed pool contractor evaluate and correct as needed.
~\$100-\$200 +/-

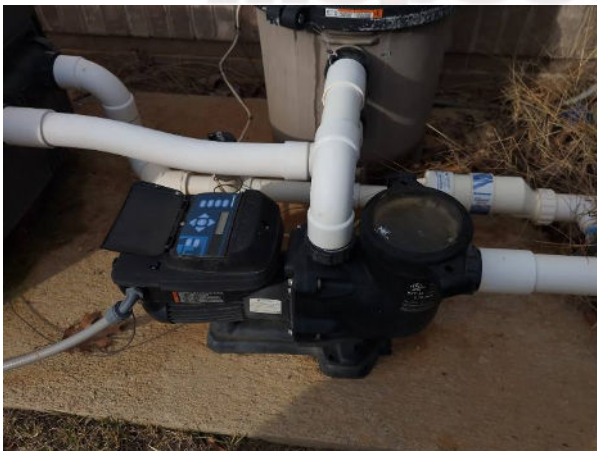
18: Pump Manufacturer: Hayward 2019

19: Motor: 2.7 HP

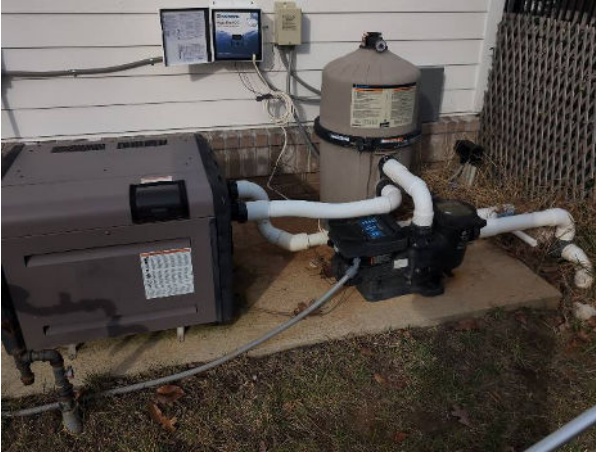
21: Having pipes properly labeled is recommended.

22: There were no issues observed with the visible piping.

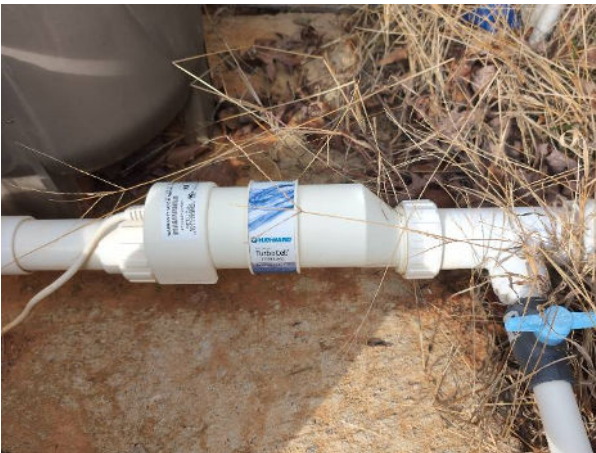
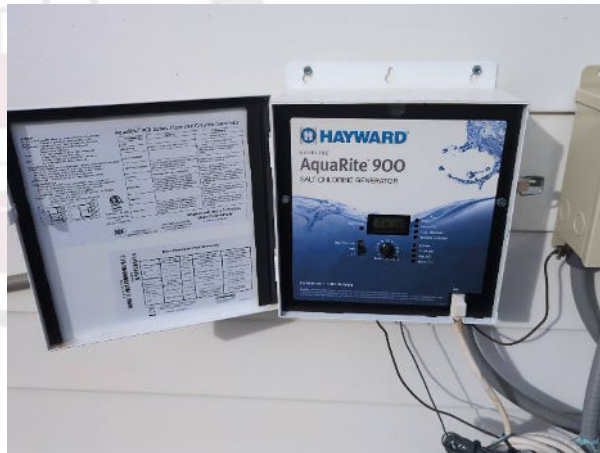
23: A salt cell was present. These typically have a life expectancy of 3-5 years, and require cleaning. Recommend asking seller the age of the cell and the service history.

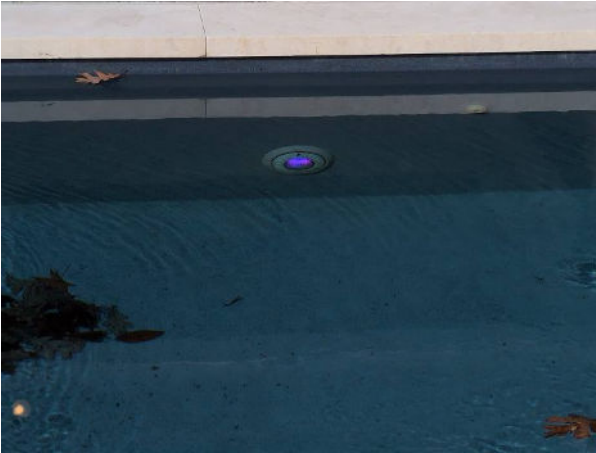
30: The pool light was functional and GFCI protected.

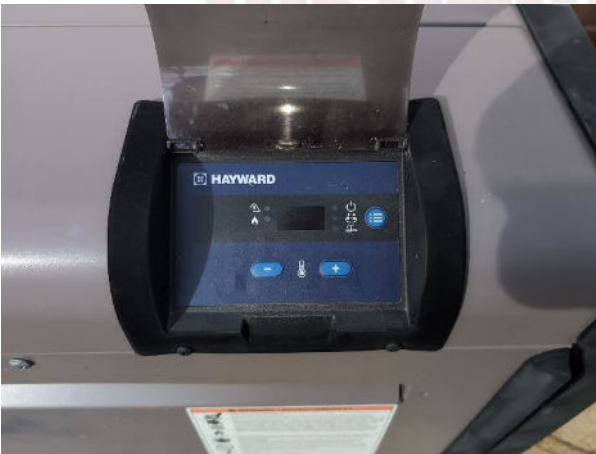
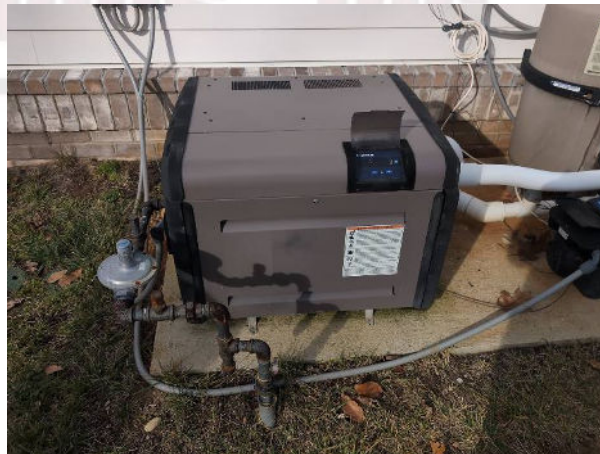
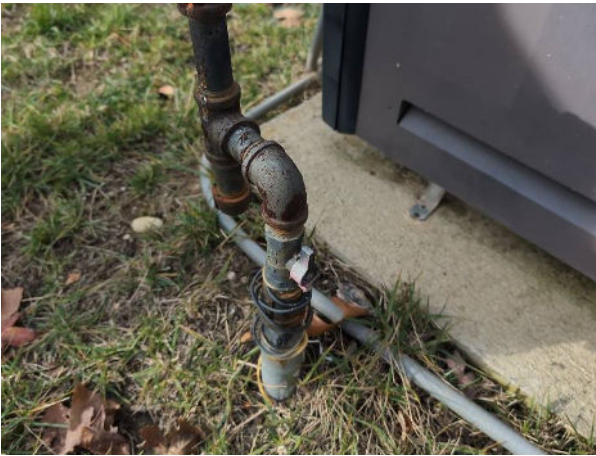
32: There was a natural gas heater installed.

33: The pool heating equipment was turned off at the breaker. Recommend checking with the current homeowner to determine the functionality.

s-33: The pool heating equipment was turned off at the breaker. Recommend checking with the current homeowner to determine the functionality.
