Confidential Inspection Report

Property Address:
123 Main St
Richmond, VA 23236

Inspector Name
State License: 3380001234 NRS Exp 1-31-2024
Burgess Inspections
530C Southlake Blvd
N. Chesterfield, VA 23236
(804) 794-1423

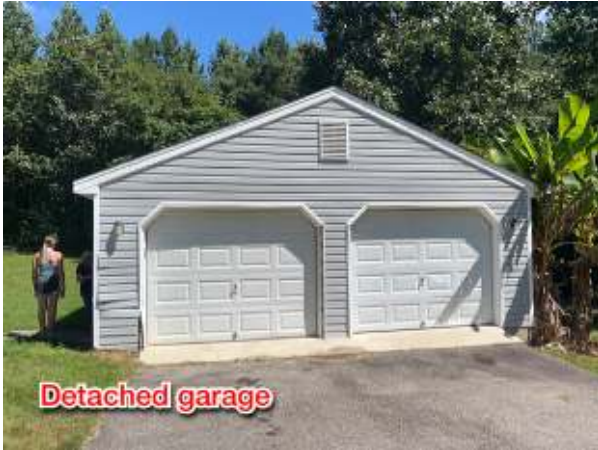
30: The front left corner of the garage has been damaged. The garage door frame has been compromised along with the front left wall.- \$800-1500

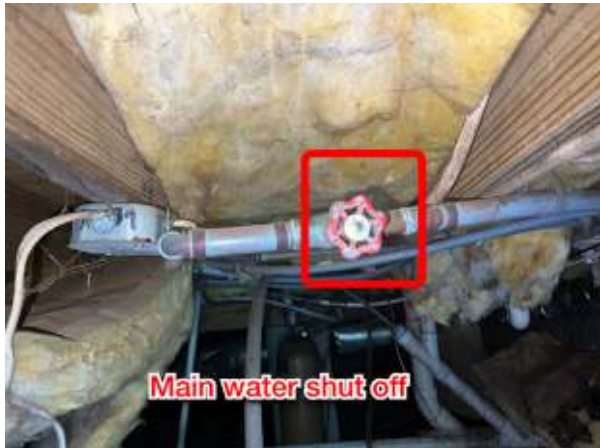
69: The main water shut off is located in the crawl space.

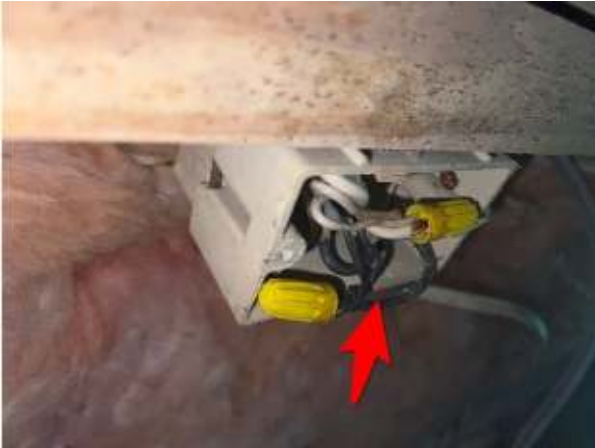
76: Open junction boxes in the crawl space that need covers installed.- \$100

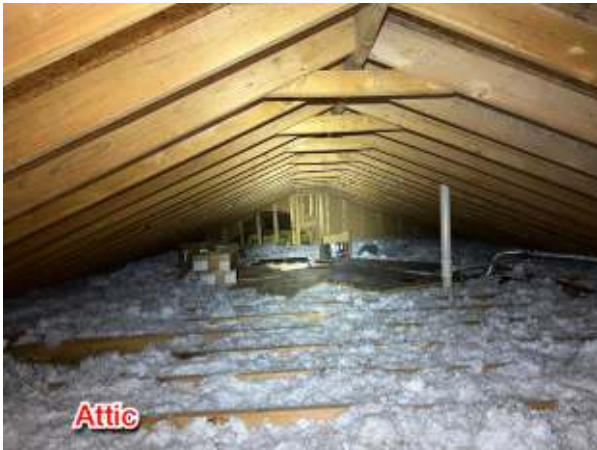
97: Minor rot to a rafter in the attic underneath the area where the roof is improperly installed over the addition.- \$200-300

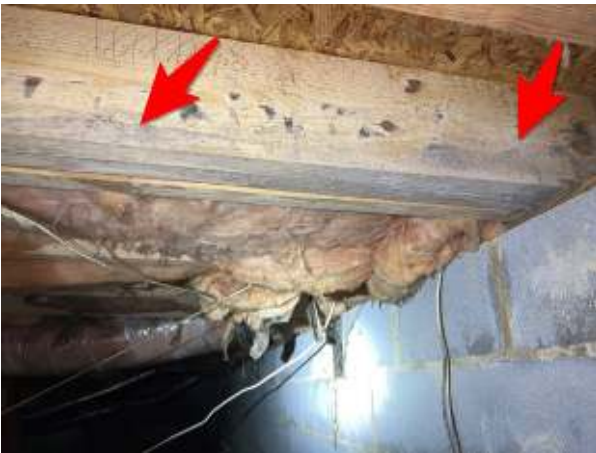
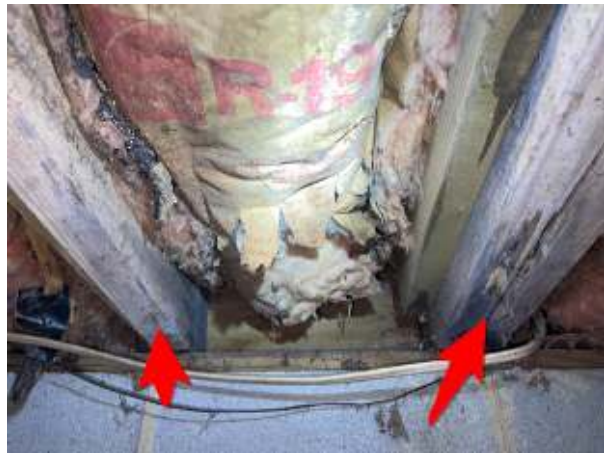
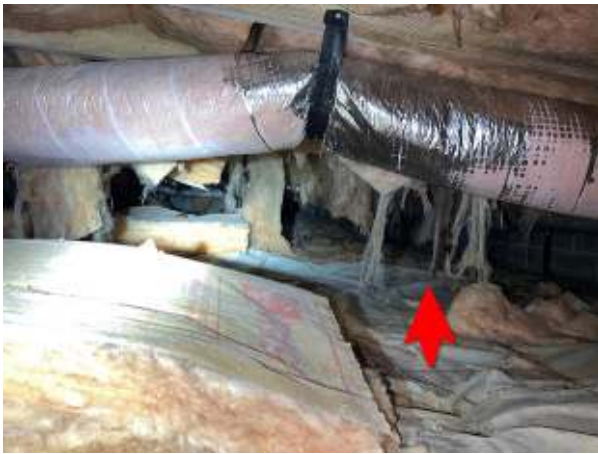
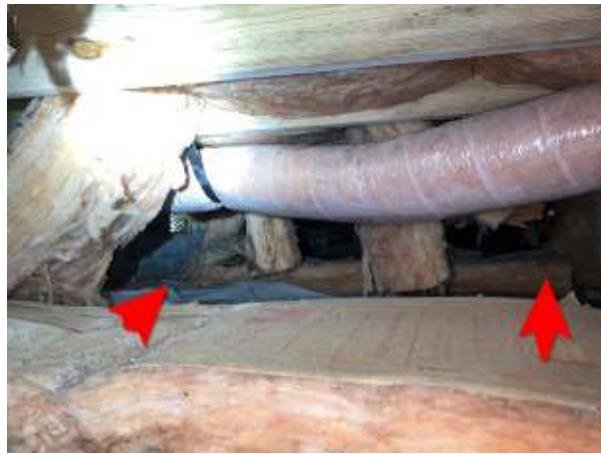
104: In the crawl space, there was a higher than normal level of fungi on the joists and ground. The insulation was feathered/hanging which is a sign of moisture. The vapor barrier was missing in many areas especially around the foundation walls. The ground was damp in these areas.- \$1000-2000
